Identification of Sediment Removal Options and Costs for Lake Garrett

Lake Garrett Mountain Park, Fulton County, Georgia

February 5, 2018

Prepared for: The City of Mountain Park

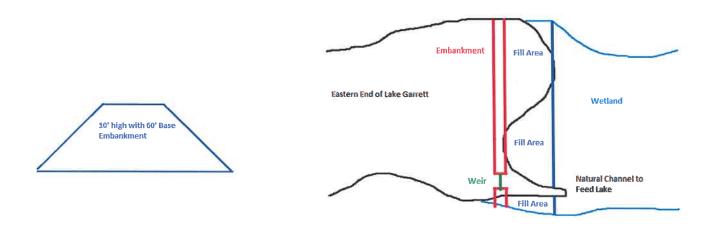
This option includes the development of a weir as previously described in Option 2.

A rough concept drawing for this option is provided below.

Once the sediments are removed and placed in the embankment, the lake bottom will be rough graded, dewatering systems removed, and site access and laydown areas restored.

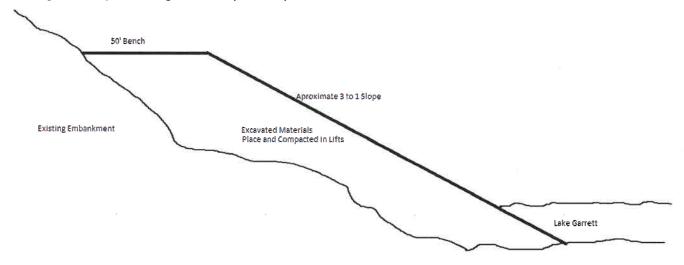
The size, length, and slope of the embankment will vary depending on the amount of excavated sediment, but it is anticipated to include an approximately 50-foot bench with an approximate 3-to-1 slope. Embankment materials will be placed, graded, compacted, and stabilized with Turf Reinforcement Material (TRM) and seeded. Drainage features would need to be installed along the top portion of the embankment as well as in up to four valleys throughout the embankment. The bench could be utilized as a greenspace, or walking/biking path.

A rough concept drawing for this option is provided below.

Once the sediments are removed and placed along the embankment, the lake bottom will be rough graded, dewatering systems removed, and site access and laydown areas restored.

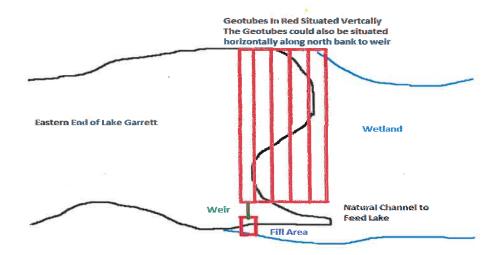
This option includes the development of a weir as previously described in Option 2. The weir would be utilized to keep the geotubes in place within the wetlands.

A rough concept drawing for this option is provided below.

After dredging is complete, it is assumed 1-to-2 months will be needed for the geotubes to drain sufficient amounts of moisture in order to place equipment on the tubes that will remove the majority of the tubes' casing such that the material in the tubes may be graded and compacted. The tube materials would be taken off-site and disposed of, the graded materials would then be seeded.

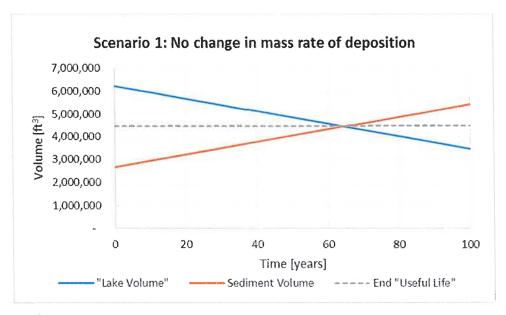
5.1.1 <u>Scenario 1: No Action</u>

If no action were taken with respect to the rate of sedimentation or the current level of sedimentation, the following graph shows the useful life of Lake Garrett:

A total useful life of approximately 65 years is anticipated with this option.

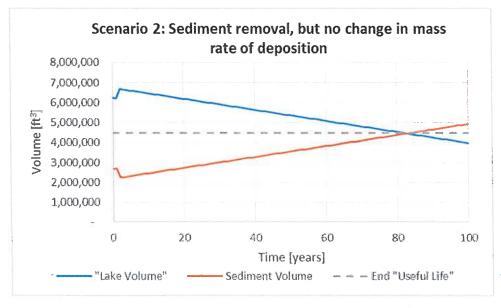
5.1.2 Scenario 2: Sediment Removal

Cardno assumed that if a minimal amount of sediment removal is completed (approximately 550,000 ft³, or approximately 20,000 cubic yards). Based on these action the following graph was generated and approximates the useful life of Lake Garrett at approximately 82 years given this scenario.

In summary, for each 1,000 cubic yards removed from Lake Garrett slightly less than one year of useful life is added.

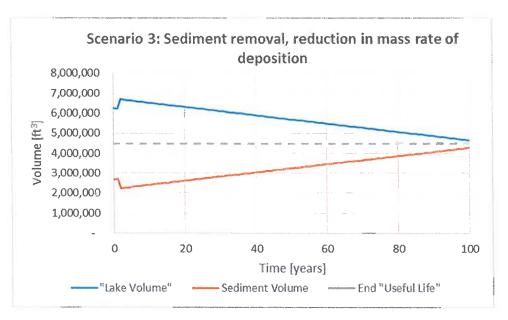
5.1.3 Scenario 3: Sediment Removal and Reduce Sedimentation Rate

The sediment level is removed by approximately 550,000 ft³, or approximately 20,000 cy, and the rate of sedimentation is reduced by half by installing a weir or sediment trap, then the following graph summarizes the useful life of Lake Garrett:

Given these factors, a total useful life of over 100 years is anticipated based on this scenario.

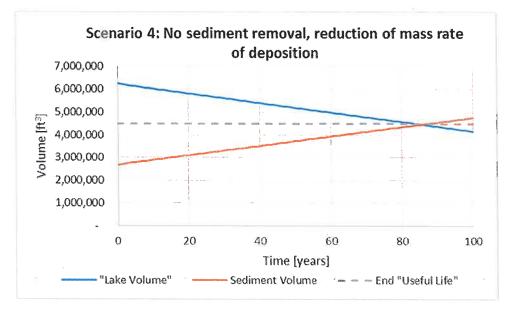
5.1.4 Scenario 4: No Sediment Removal and Reduce Sedimentation Rate

If no sediment removal is conducted and the rate of sedimentation is reduced by half by installing a weir or sediment trap, then the following graph summarizes the useful life of Lake Garrett at roughly 82 years.

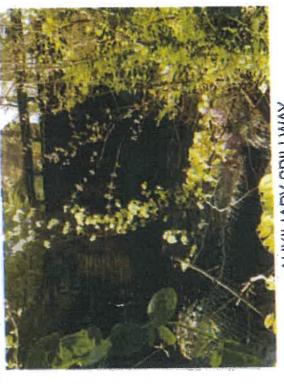
AUXILIARY SPILLWAY

c. Was leakage observed at pipe joints?			Not checked
S. Auxillary Spillway	9.5		
a. Is vegetative cover inadequate?			Concrete spillway, some erosion D/S of stro
